To assess the results of vibration measurements undertaken during construction works, relative to the guidance given in BS 5228.

## Construction Vibration Assessment Elgin Academy

Technical Report No. R-5247B-DL4-UC  
25 October 2010

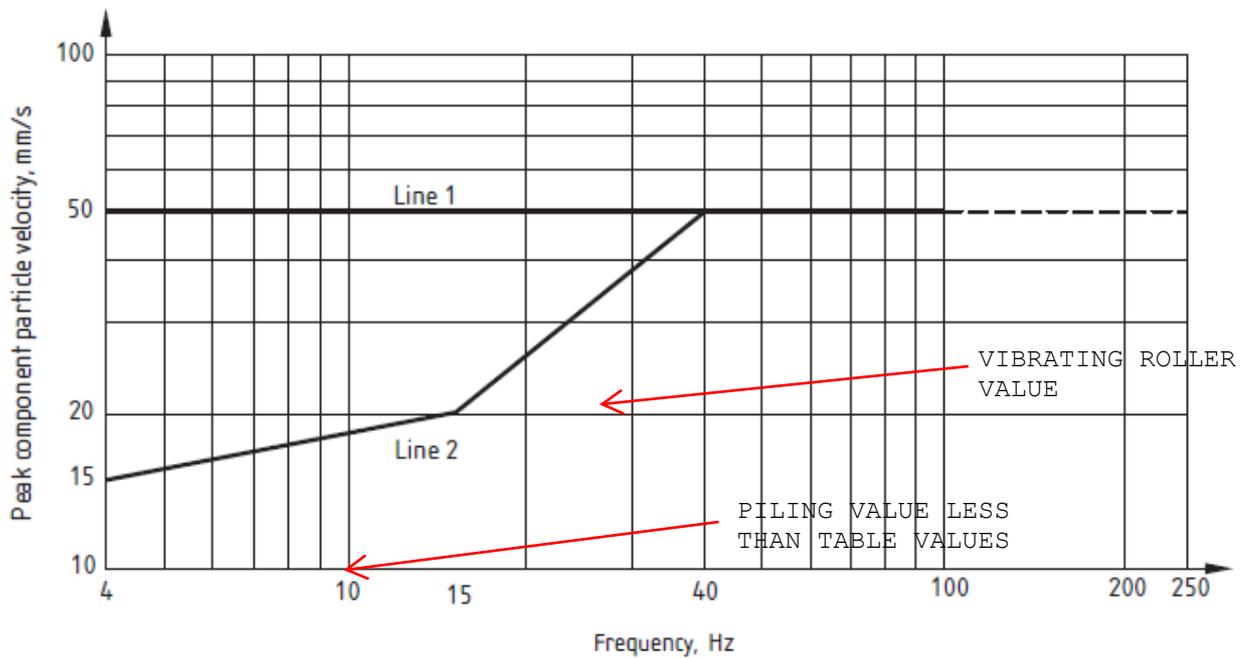
2.2 Figure B.1 of BS 5228-2, reproduced below, gives indicative values for the onset of minor cosmetic damage to buildings, relative to the vibration level at the base of the building. Line 1 is appropriate to industrial and heavy commercial buildings whilst Line 2 is relevant to residential and light commercial buildings.

4.5 Given a distance of 55 m between the piling toe and monitoring location, and a distance of 88 m between the piling toe and receiver location, the resultant peak particle velocity at the closest residential property as a result of piling activities is calculated to be **4.3 mm/s**. It should be noted that the dominant frequency range for vibration from piling is above 10 Hz. This level does not exceed Line 2 of Figure B.1 of BS 5228-2.

4.7 Given a distance of 75 m between compacting and monitoring location, and a distance of 58 m between the compacting and receiver location, the resultant peak particle velocity at the closest residential property as a result of the vibrating roller with a drum width of 2.1 m (as per manufacturers' information) is calculated to be **20.9 mm/s**. It should be noted that manufacturers' data indicates the dominant frequency of the vibrating roller to be 28 Hz. This level does not exceed Line 2 of Figure B.1 of BS 5228-2 at the appropriate frequency.

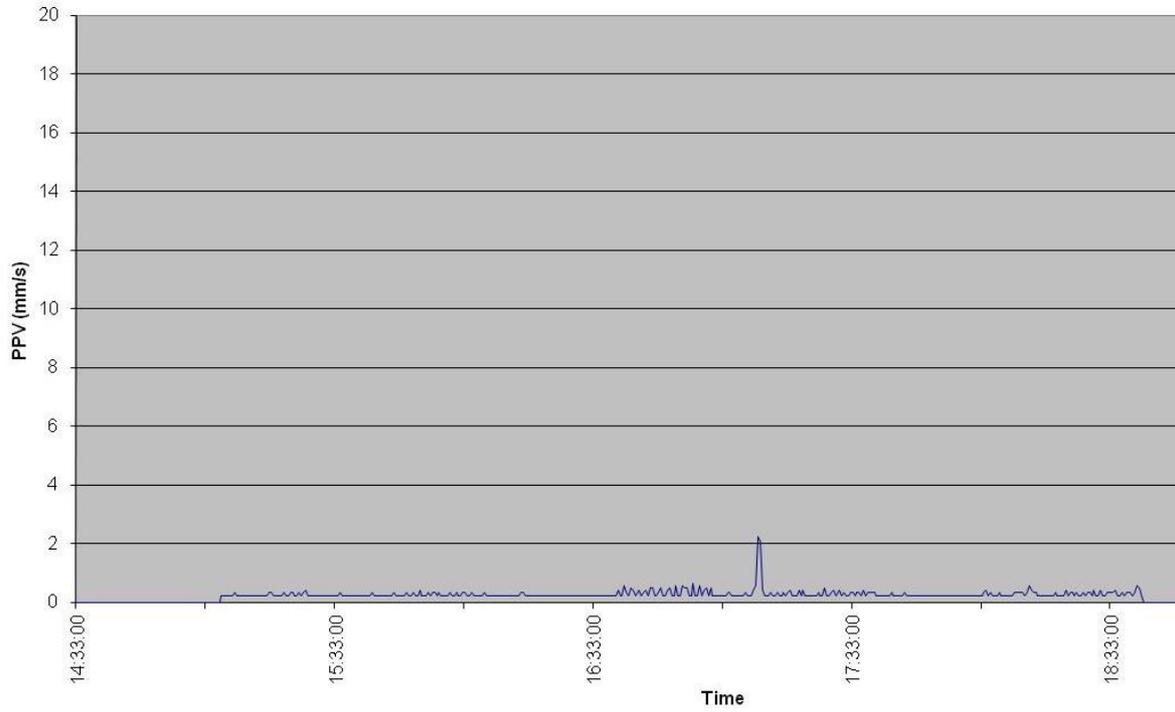
**Figure 1. Vibration monitoring results, 02/09/2010**

3.5 Figures 1 to 5 show the results of vibration monitoring during the piling exercise.

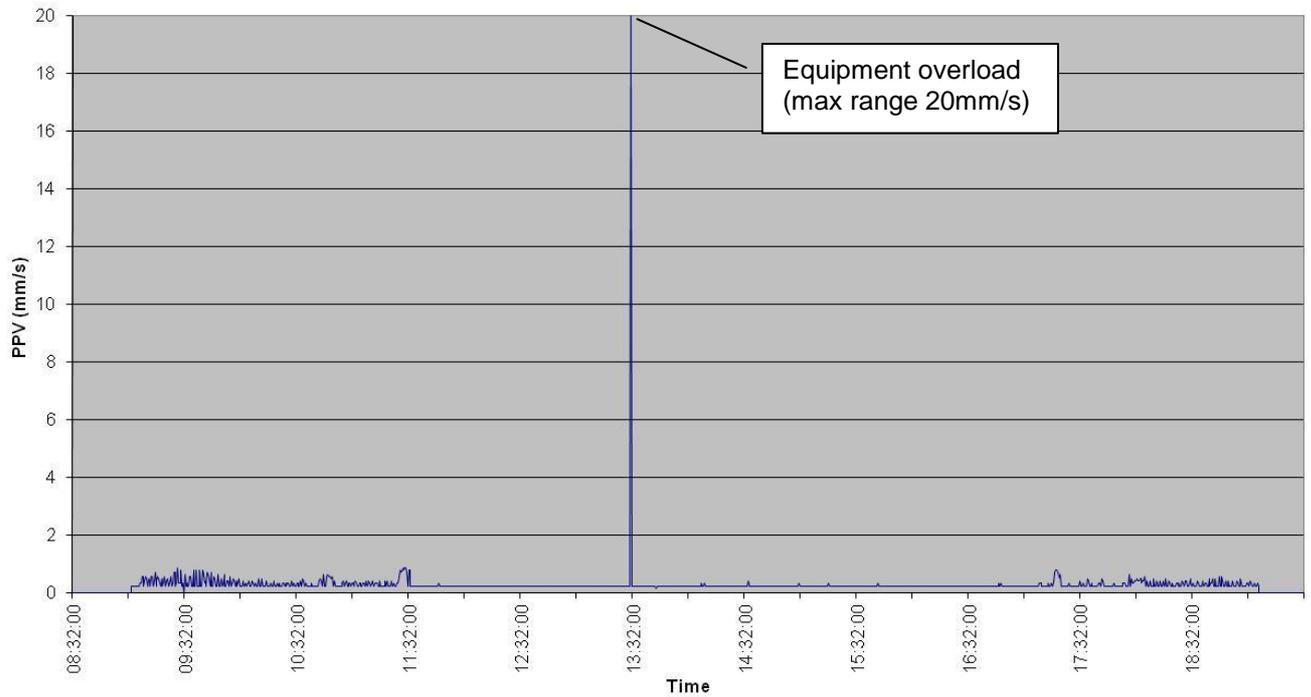
**Figure 2. Vibration monitoring results, 03/09/2010**

3.6 The peak measured at 13:00hr on 03/09/10 is not characteristic of vibration from piling activities, but is rather thought to be due to a member of the public interfering with the monitoring equipment during the lunchtime period.

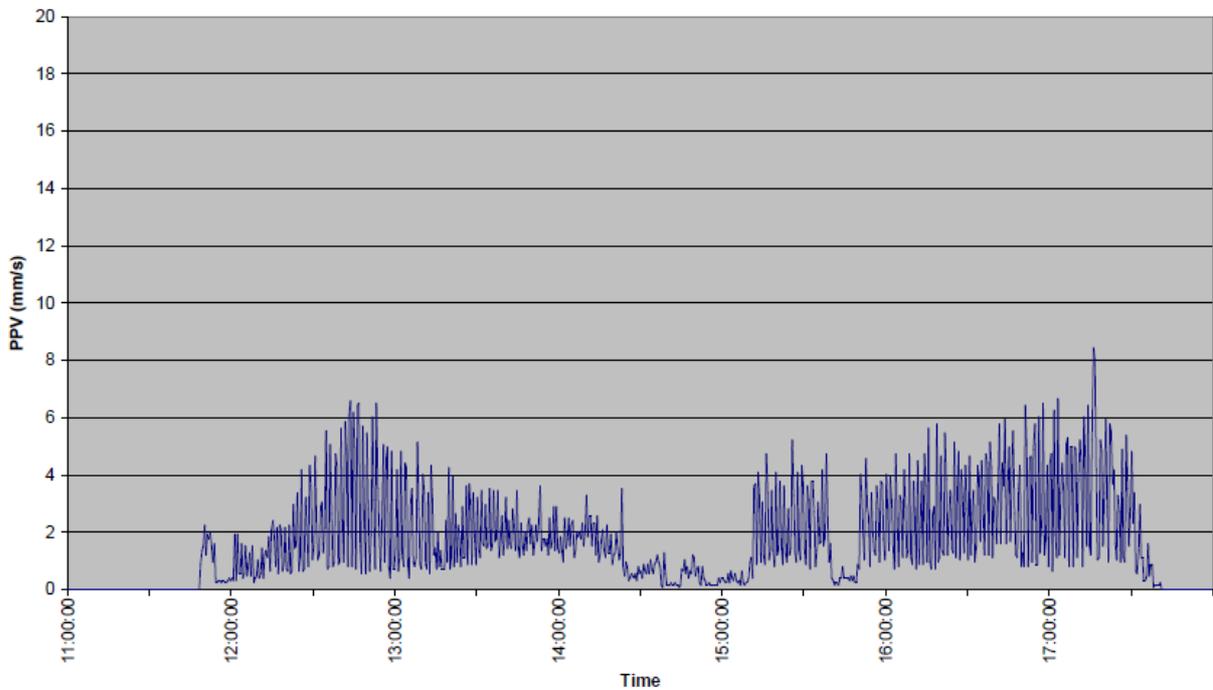
**Figure 3. Vibration monitoring results, 23/08/2010**

3.7 The following figures detail the measured vibration levels from piling and compacting on the site. From the shapes of the graphs it is expected that vibration levels on 23/08/10 were dominated by piling, with vibration levels on 25/08/10 and 27/08/10 dominated by the vibrating roller.

- 4.1 From analysis of all results, the piling operations are estimated to have caused vibration levels at the monitoring location of up to 8 mm/s (at around 17:20 hrs on 23/08/10). From site records, it is known that the piling rig at this time was located approximately 55 m from the monitoring location, and 88 m from the nearest residential property.

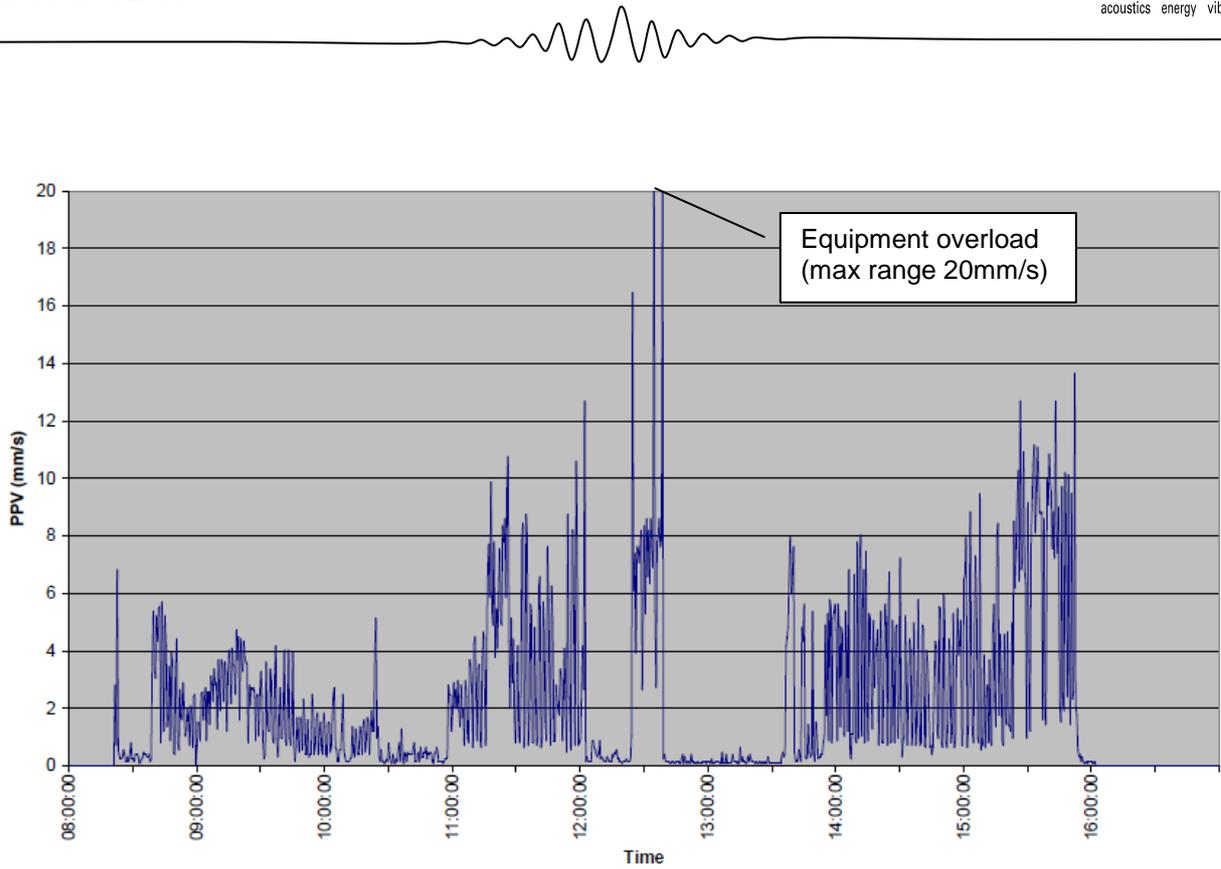
**Figure 4. Vibration monitoring results, 25/08/2010**

- 3.8 The highest recorded values are understood to have occurred when the compacting equipment was operating close to the monitoring location and will not be representative of vibration levels at the nearest residential properties. Overloading of the equipment occurred at this level, and as such alternative periods should be used for analysis.
